Reilly Tar ? Chemical Corp. RCRA-Permits

Corrective Action Requirements. Visual Site Inspection of Reilly Tar & Chemical Corporation, Granite City, Illinois

PCRA Facility Assessment (RFA) File, ILD 006278360

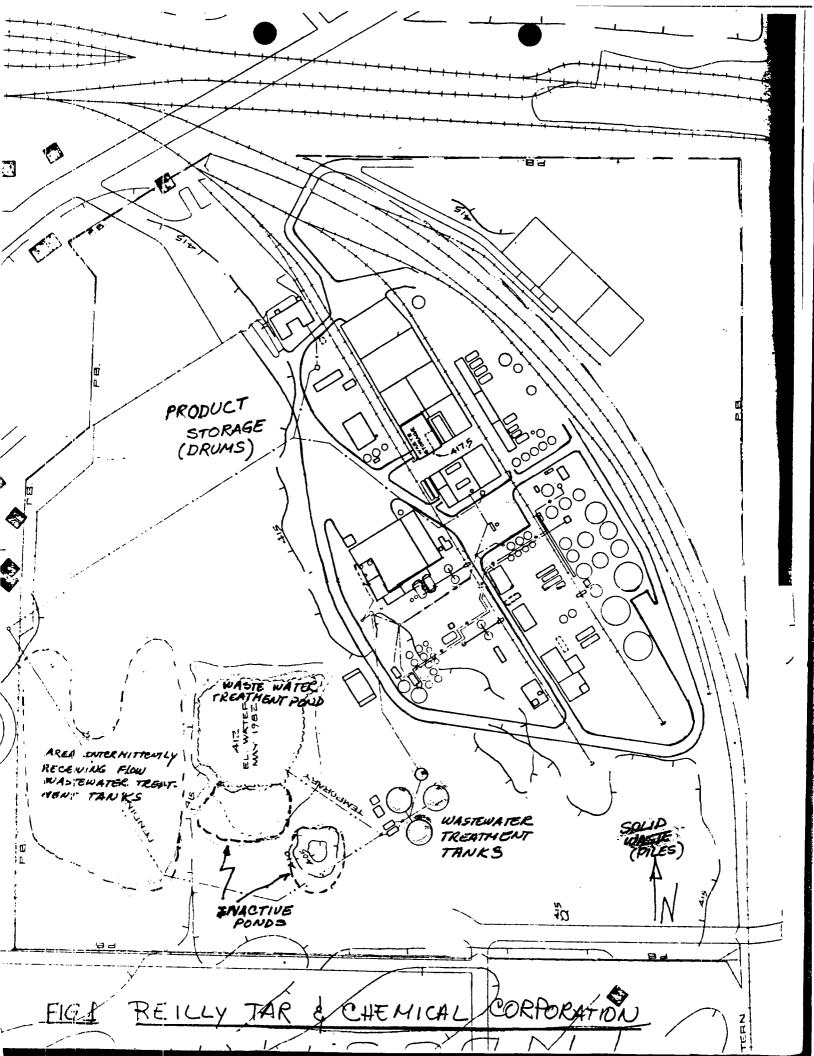
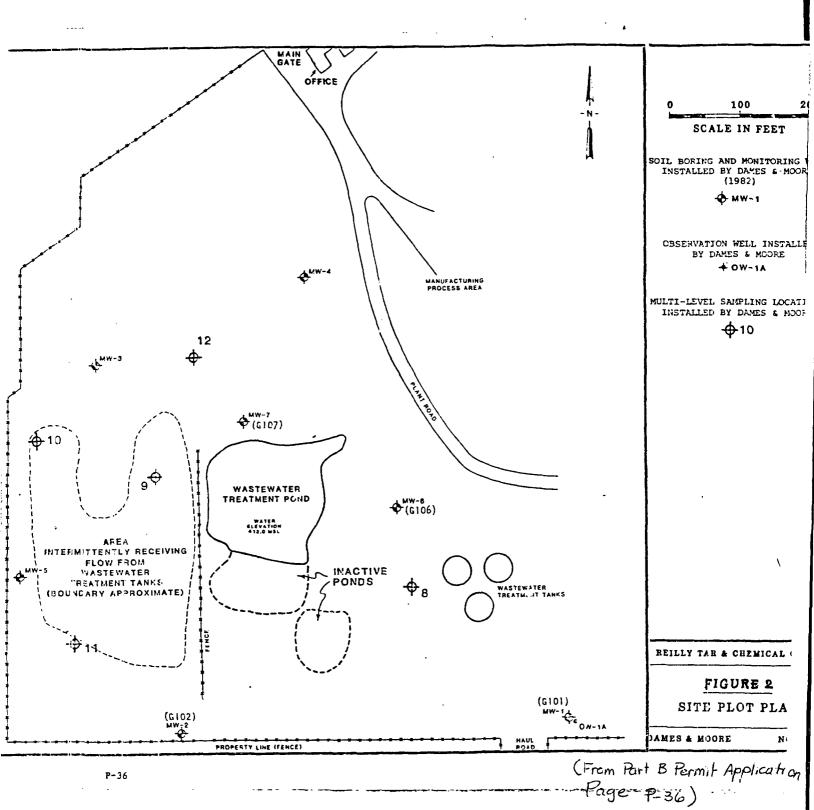
The following is a summary of the information gathered during the site inspection. Please refer to Figures 1 and 2, which show the areas inspected. These include the manufacturing process areas and the waste handling areas.
